Re: H2-Oh-Yeah (Steamtown)

Notice of Violation (NOV)

Subject: Notice of Violation

Ohio EPA, Division of Surface Water (DSW) performed an inspection of the H2-Oh-Yeah Anaerobic Treatment Lagoon (Steamtown ATL) on February 23, 2022. The goal of the inspection was to determine your facility's compliance with Ohio's environmental laws and regulations and the terms and conditions of the Steamtown Land Application Management Plan (LAMP) issued on April 1, 2019, and Permit-to-Install (PTI) No. 1278450 issued on February 12, 2019.

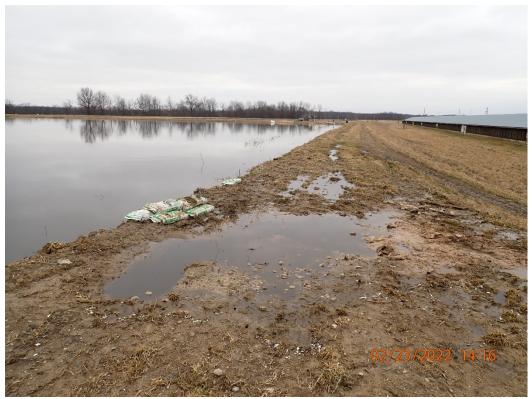
West side of North Lagoon, facing south

(a) **Violation Description:** During the inspection on February 23, 2022, the level of material in the North Lagoon was observed to be at the top of the berm. No additional storage capacity for material or rain was available in the North Lagoon.

- (b) **Additional Information:** The January monthly report indicated a freeboard of 2.0 feet on January 31, 2022.
- (c) **Requested Action:** Immediately begin removing material from the North Lagoon and take the material to a permitted NPDES facility for treatment. Enough material needs to be removed from the North Lagoon to maintain the required freeboard of 1.5 feet. No new material shall be added to the lagoon system until this violation is resolved by Ohio EPA.

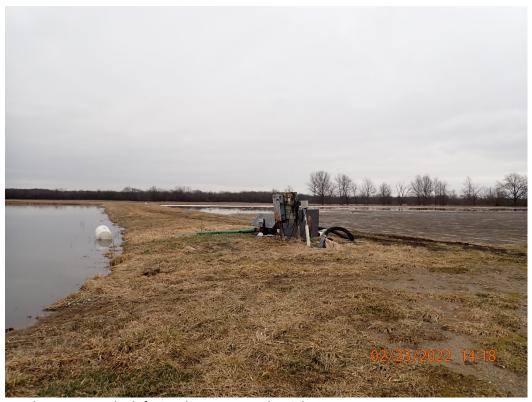
North Lagoon on the left, South Lagoon on the right

- (a) **Violation Description**: During the inspection on February 23, 2022, the South Lagoon was observed to be less than 1 foot from the top of the berm.
- (b) Requested Action: Lower the level of the South Lagoon. This may be accomplished by gravity flow once the North Lagoon has been lowered to allow additional storage while still maintaining the required freeboard or by taking the material to a permitted NPDES facility for treatment. Enough material needs to be removed from the South Lagoon to meet the required freeboard of 2.0 feet. No new material shall be added to the lagoon system until this violation is resolved by Ohio EPA.
